NINTH ANNUAL SUMMARY REPORT

Flight Service Program for Advanced Composite Rudders on Transport Aircraft

DOUGLAS AIRCRAFT COMPANY
LONG BEACH, CALIFORNIA 90846

CONTRACT NAS1-12954
SEPTEMBER 1985

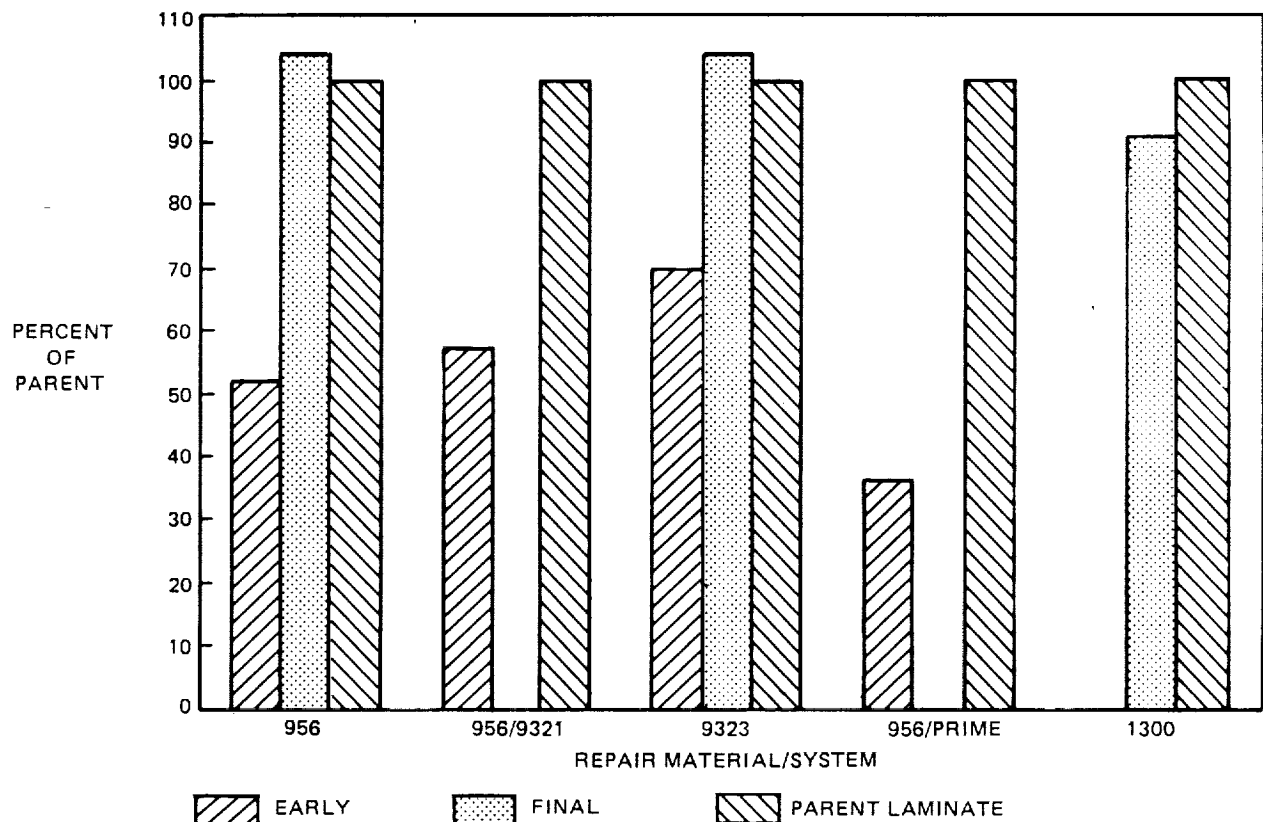
FIGURE 5. REPAIRED LAMINATE STRENGTH

Early tests indicated that a wet laminated repair system would not have sufficient strength. However, the repair scarf geometry and processing conditions were developed until the repair strength was able to exceed the autoclave cured parent material strength, as shown in Figure 5. The material systems evaluated were Hysol EA956, EA9323, EA956 with an EA9321 adhesive interface, EA956 with BR127 primer, and Ciba Geigy CG1300.

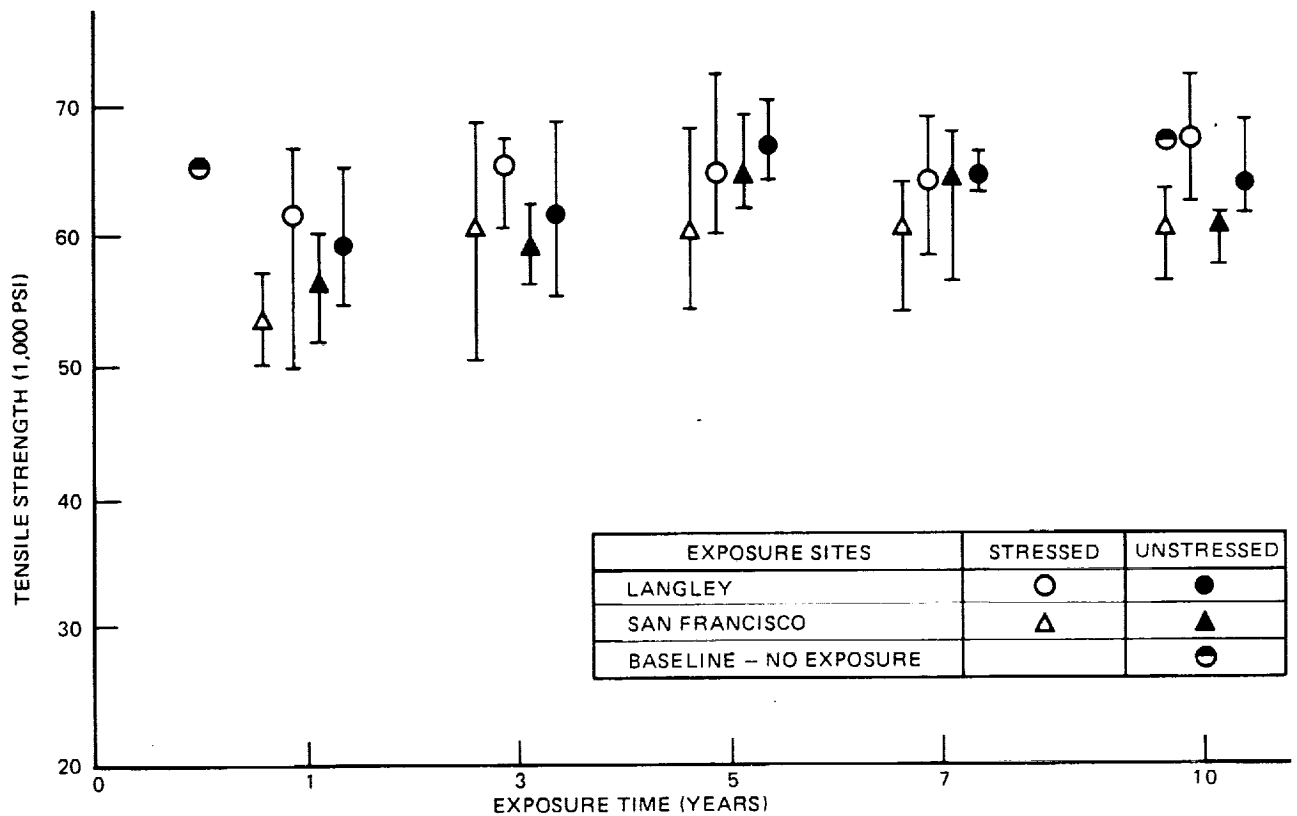
FIGURE 19. AVERAGE TENSILE STRENGTH VERSUS EXPOSURE TIME FOR ENVIRONMENTAL SPECIMENS

The test program has now been completed. In general, the residual tensile strengths of the outdoor specimens are within the scatter band for the strength of the baseline specimens. The test results indicate that the T300/5208 quasi-isotropic tensile specimens were unaffected by either the outdoor environment or the sustained tensile stress at the two exposure sites indicated. The test results are summarized in Tables 11 through 16 and in Figures 19 and 20.
